## Inventory report

**99 Any Road  
Anytown,  
Gloucestershire**

**Prepared for: A N Letting Agents**

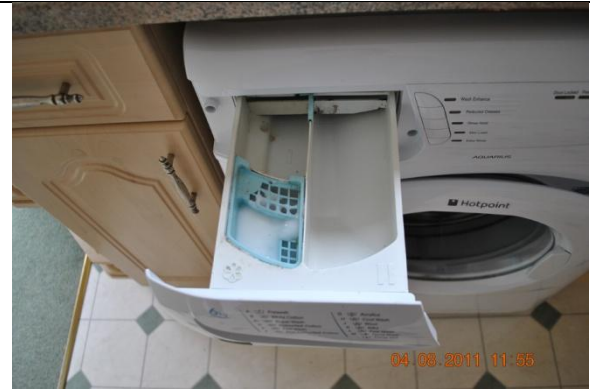
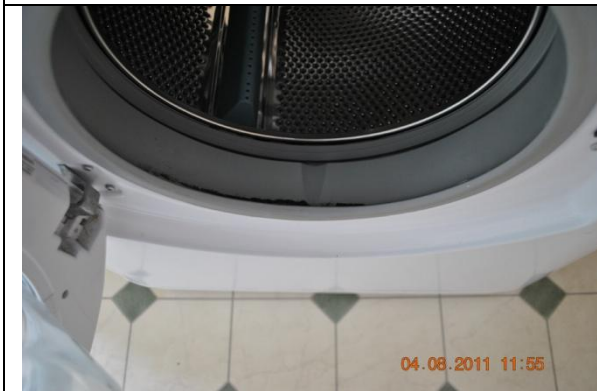
| 44 Washing machine (property of new tenant) | <p>Hotpoint Aquarius</p> <p>Powder tray – dirty<br/>Glass in door – dirty<br/>Mould marks to rubber door seal<br/>Drum clear.</p> | |

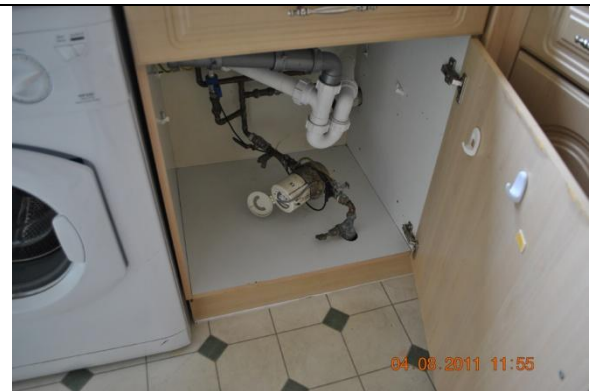
38

| <p>38 Kitchen units</p> | <p>White surround, tiled sill.</p> <p>Pale brown wood with silver coloured metal handles.</p> <p>Units are assumed working, empty and clean unless otherwise mentioned. Shelf count treats the base of a unit as one.</p> <p>Working from left to right starting with the top units.</p> <p>Unit One – boiler unit. Wear to bottom front left of unit. White paint mark on left wall of cupboard.<br/>Set of four gold coloured metal key hooks on a varnished wooden plinth.<br/>Unit is open bottomed and open topped.</p> <p>Unit Two – two shelves, blue scuff top middle on back wall. Top of door greasy.</p> <p>Unit Three – two shelves. Dust on top shelf.</p> <p>Unit Four – two shelves. Moores stick on front of top shelf.</p> <p>Unit Five – glass fronted, bottom left corner of design on glass coming away from surface.<br/>Two shelves.<br/><br/>Two shelves with wooden carved edges.</p> <p>Bottom units working left to right.</p> <p>Two shelves with carved wooden edges.</p> <p>Unit Six – drawer at top with two shelf unit below. Top shelf set back from door.</p> <p>Unit Seven – fake drawer at top, cupboard at bottom under sink housing exposed piping and water meter.</p> <p>Unit Eight – drawer at top with scuff marks to bottom of inside. Two shelf unit below, some dirt on both shelves.</p> <p>Unit Nine – fold out door with fake drawer on top. Missing bit of laminate cover in top left. Two shelves with dirt marks to both.</p> <p>Unit Ten – five shelf wine rack, space to two</p> | |

| | <p>bottles per shelf.</p> <p>Unit Eleven – drawer at top with white paint mark to bottom of drawer front and scuff marks to bottom of inside. Unit below has two shelves, top shelf set back from door. Scuffs to bottom shelf.</p> | |

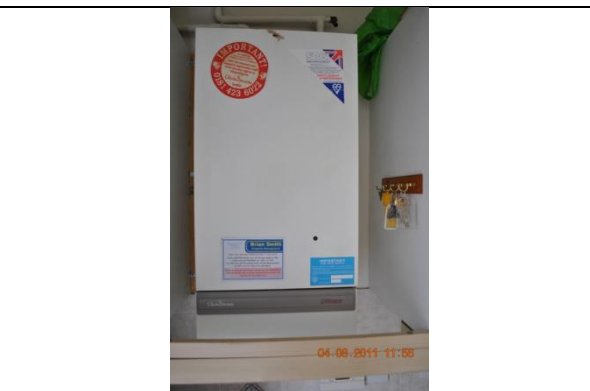
| 39 Boiler | <p>Glowworm</p> <p>Safety stickers on front.<br/>Rust mark top middle of front, dirt on right side.</p> | |
